# The disastrous 17 February 2006 rockslide-debris avalanche on Leyte Island, Philippines: a catastrophic landslide in tropical mountain terrain

S. G. Evans, R. H. Guthrie, N. J. Roberts, N. F. Bishop

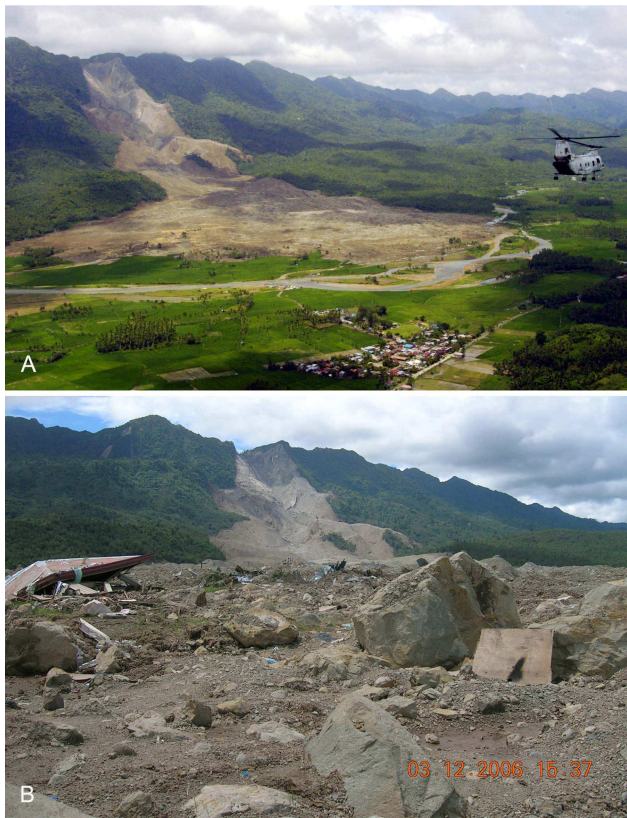
**Fig. 1.** (A) Oblique aerial view (to the northwest) of the Guinsaugon landslide taken on 19 February 2006. (U.S. Navy photograph by M. D. Kennedy). The Himbangao River flows from right to left. (B) View of debris toward the source area of the rockslide-debris avalanche (Photograph taken 12 March 2006).

On 17 February 2006 a disastrous landslide occurred in Southern Leyte Province, Leyte Island, the Philippines (Lagmay et al., 2006; Fig. 1). It originated on a steep 450 m high, heavily-forested rockslope and swept down into the densely-populated Himbangao River valley. The landslide overwhelmed the village of Guinsaugon resulting in the loss of over 1100 people, including 250 schoolchildren who were attending morning classes at the Guinsaugon School.

The landslide (Figs. 1, 5) occurred between 10:30 a.m. and 10:45 a.m. on the morning of 17 February 2006. An eyewitness interviewed during field work said that the landslide started with a shaking of the ground, followed by the sound

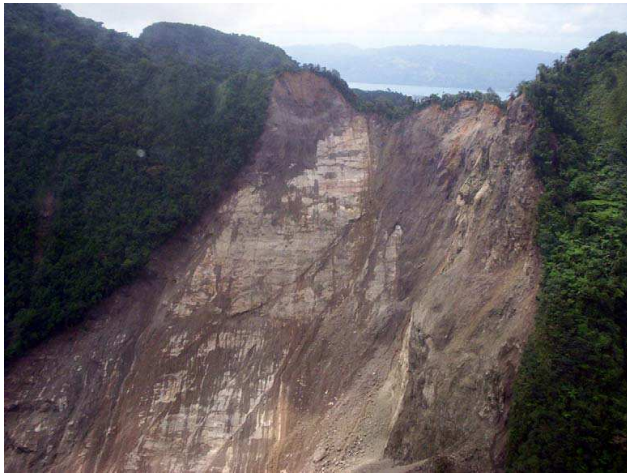
**Fig. 8.** Aerial view of the sliding surface showing horizontal striations consistent with strike-slip fault movement. Note also rock mass characteristics on the right of the source area resulting from movement of Philippine Fault (Photograph courtesy of Mines and Geosciences Bureau, Government of the Philippines).

As noted above the initial failure involved a steep ( $48^\circ$ ) forested rock slope that forms the east facing slope of a NNW-SSE trending ridge (Figs. 7, 8). Satellite imagery and helicopter observations indicate that this sharp-crested ridge has undergone notable slope displacements (Figs. 7, 8). This is manifested in slipped masses and tension cracks along the crest of the ridge (Fig. 8). The source of the rockslide-debris avalanche is located within the damage zone (Kim et al., 2004) of the Philippine Fault; the site of the landslide is traversed by the main trace of the Philippine Fault (Figs. 6, 7,

8) and it appears that a splay of the fault formed the steep sliding surface of the initial rock slope failure (Figs. 5b, 8).

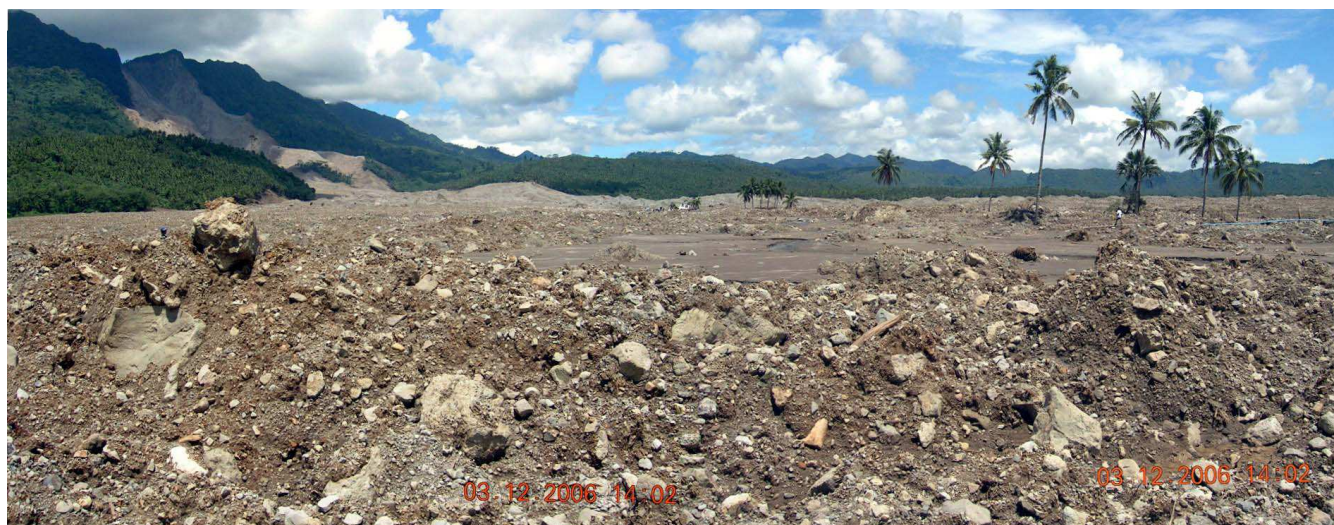
**Fig. 9.** View from near the distal limit of the debris toward the source area. Note matrix supported nature of the debris at this distal location and flat surface, corresponding to rice paddy fields, over which the debris ran in the distal part of its path. Debris thickness here is about 2 m.

Debris deposited on the valley floor is dominated by finer grain sizes which forms a matrix-supported deposit (Figs. 9, 10), despite the fact that large boulders are present (Fig. 11a). This may reflect the entrainment of finer-grained colluvium by the leading edge of the rockslide-debris avalanche from the base of the source slope and/or the mixing of the rockslide-debris avalanche debris with the saturated sediments from paddy fields on the valley floor. The distal limit of the debris consists of series of irregular lobes on the flat valley floor, (Figs. 10a, b) which are rimmed by a zone of dark mud. This represents the fine muds ejected from beneath the moving debris sheet during the final part of its travel over the paddy fields. In some places we noted that trees and buildings were destroyed by the ejected mud beyond the limit of the coarser debris (Fig. 11b).

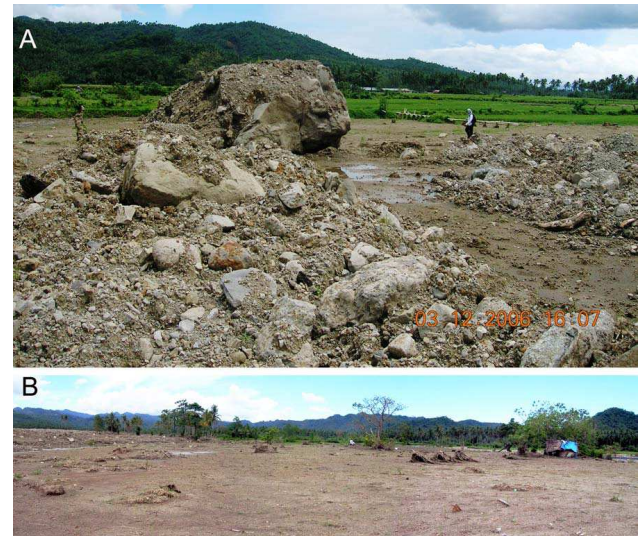
**Fig. 11.** Distal limit of rockslide-debris avalanche. (A) characteristics of debris, including large boulder (B): damage to trees and houses by fine mud ejected from base of debris sheet, the limit of which is seen at left.

The debris contains large boulders up to 5 m in diameter, transported in some cases to the distal limit of the debris (Figs. 1b, 11a). As noted above, a significant part of the debris is made up of a fine-grained matrix including significant amounts of silty sand, sandy silt, and low plasticity clay (Liquid Limit = 48 and Plasticity Index = 22), reflecting the composition of the sheared source rock mass and the colluvium entrained from the base of the rock slope.
